SUBJECT: 6.0 L Injector Stiction Discussion and Recommendations

January 2009

Reference [TSB 08-26-3](#)

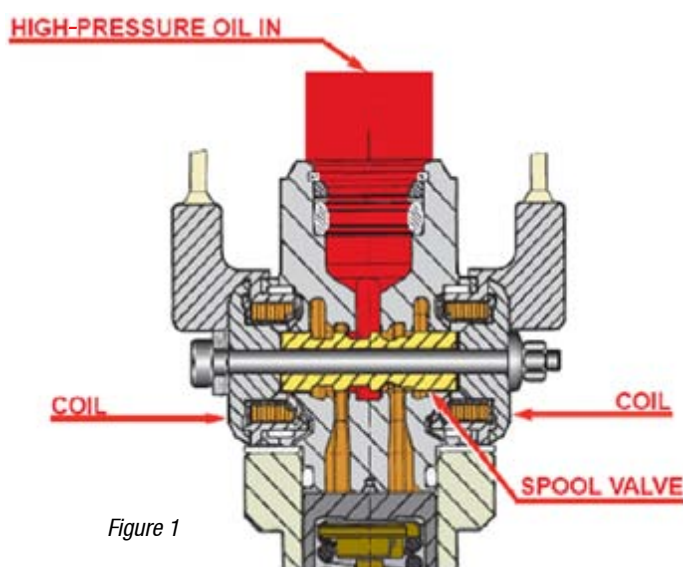
Figure 1

The spool valve is located in a bore in the stator housing; coils and coil housings positioned on both ends of the stator housing serve as end caps to seal the assembly and limit spool valve travel (0.432 mm). An open coil on one side of the stator housing and a closed coil on the other are alternately energized during engine operation to move the valve horizontally. The spool valve has two positions—movement of the valve positions the valve over drillings in the stator housing which either (1) allow high-pressure oil from the oil rail into the injector high-pressure oil pumping chamber, or (2) allow pressure in the high-pressure oil chamber to collapse and oil to exhaust from the injector. Open coil energization allows high-pressure oil into the high-pressure oil pumping chamber; close coil energization allows oil to exhaust from the pumping chamber; when neither coil is energized, the valve will remain where it was last positioned (in Figure 1, below, the close coil is shown on the left side, and the spool valve is in the closed position; also note the gap between the spool valve and the open coil on the right side).
