APT 03/12

SUBJECT: GM 6.6 L LB7 Duramax Fuel Return Line Banjo Bolt

June 19, 2012

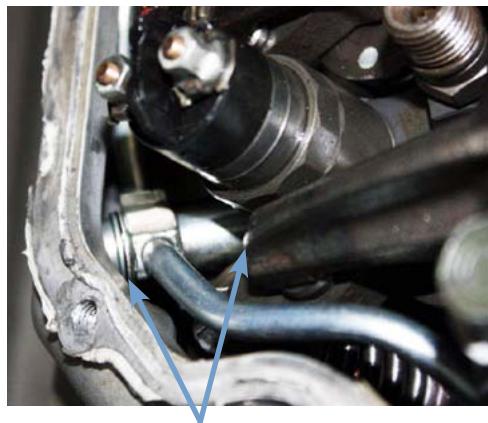
The fuel return lines on the 2001–2004½ GM 6.6 L LB7 Duramax are located under the valve covers and rocker housings. The return lines are connected to the injectors with banjo bolts. If the banjo bolts are not tightened properly they can cause return fuel to leak into the engine, diluting the engine oil with diesel fuel (possibly leading to severe engine damage). Accessing these bolts is time consuming and reusing damaged banjo bolts can be a costly practice in the long run.

Return Line Leak Points

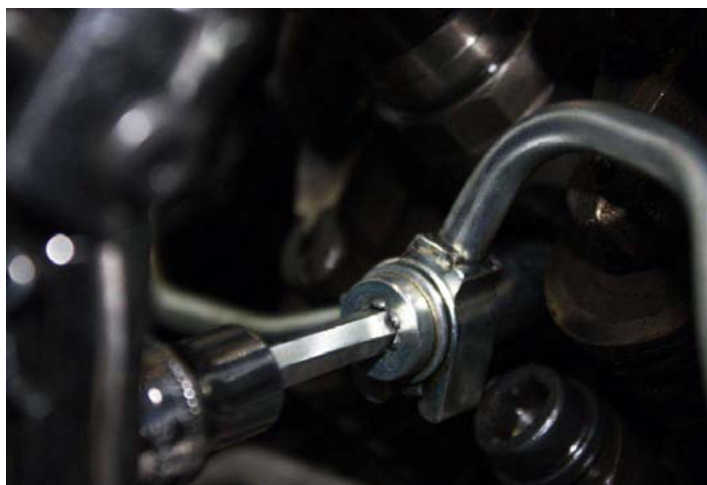
Banjo Bolt Installation

The fuel return line banjo bolt has a torque value of 12 lb–ft and requires a 5 mm Allen wrench to be removed and installed. The Allen head can be problematic and often strip, making it difficult to properly torque the banjo bolt on installation.

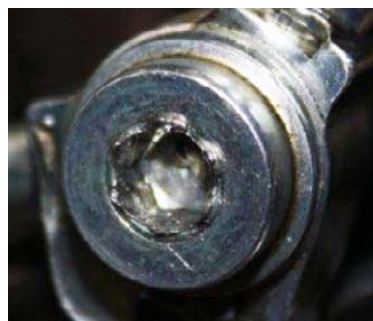
Damaged Banjo Bolt

Alliant Power recommends that all banjo bolts for the 2001–2004½ LB7 Duramax be thoroughly inspected any time they are removed. Replace using Alliant Power part number **AP0059** if there are any signs of damage or stripping of the Allen head. Failure to do so can result in severe engine damage.
