# **DIAMOND DIESEL and TURBOCHARGER SERVICE, Inc.**

## 7.3L INJECTOR SLEEVE REPLACEMENT

TEXT AND PHOTOS BY MIKE MCGLOTHLIN

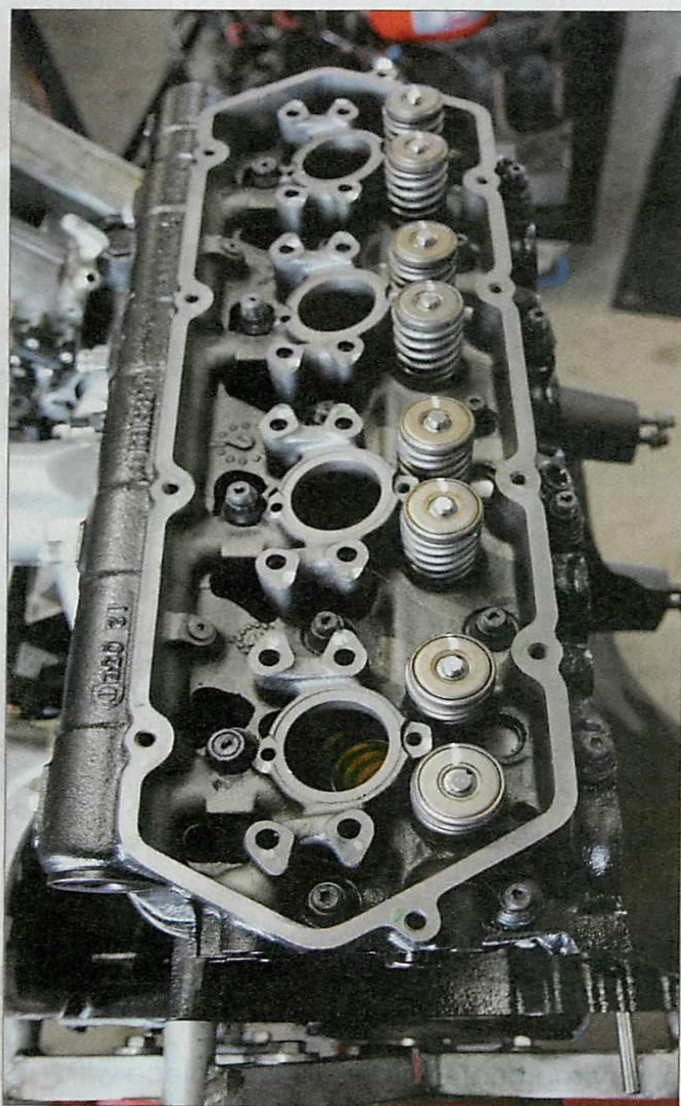
Although the task can be performed with the heads still on the block (and the engine still in the truck), it's easiest to pull the cylinder heads. The first order of business for Flynn was cleaning each injector hole with brake cleaner (to make sure no foreign debris obstructed the puller tool's operation).

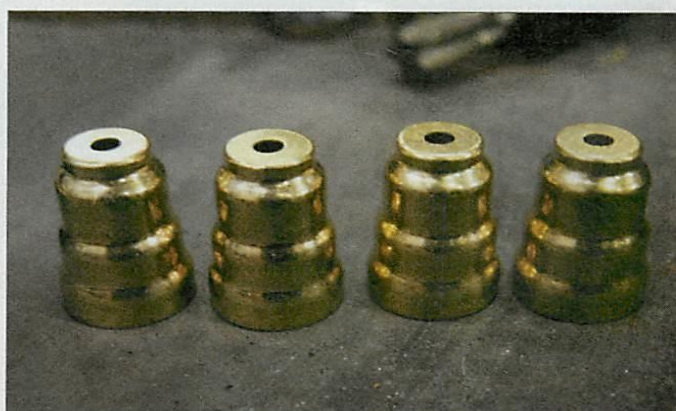
Each 7.3L Power Stroke injector sits in one of these brass sleeves, which is pressed into the cylinder head. Its purpose is to keep the injector and fuel separate from engine coolant, as well as help seal the fuel side of the injector. When a sleeve splits or cracks, you'll find fuel in the cooling system. This is because the 7.3L's fuel system typically sees 60 to 70 psi of fuel pressure, as opposed to less than 16 psi in the cooling system (essentially, fuel wins the battle and contaminates the cooling circuit). Being quite labor intensive, it's best to replace all of them at the same time.

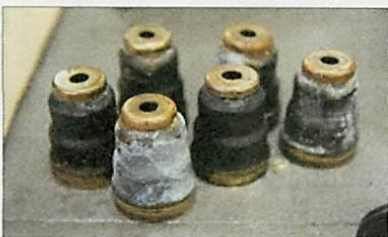
In this photo, you can see that only the top and bottom of the sleeves make contact with the injector bore (the centersection does not touch the bore). This is where the sealer is applied to the new sleeves before they're installed.
